## Rocker Arm Needle Roller Bearing Replacement

While rare, our boxers have on occasion been known to experience failure of the needle roller bearings in the cylinder head rocker arms. From memory pre 1974 model airheads used bushed rockers. While the repairs for both models are similar, this example shows my repair procedure to a later needle roller model.

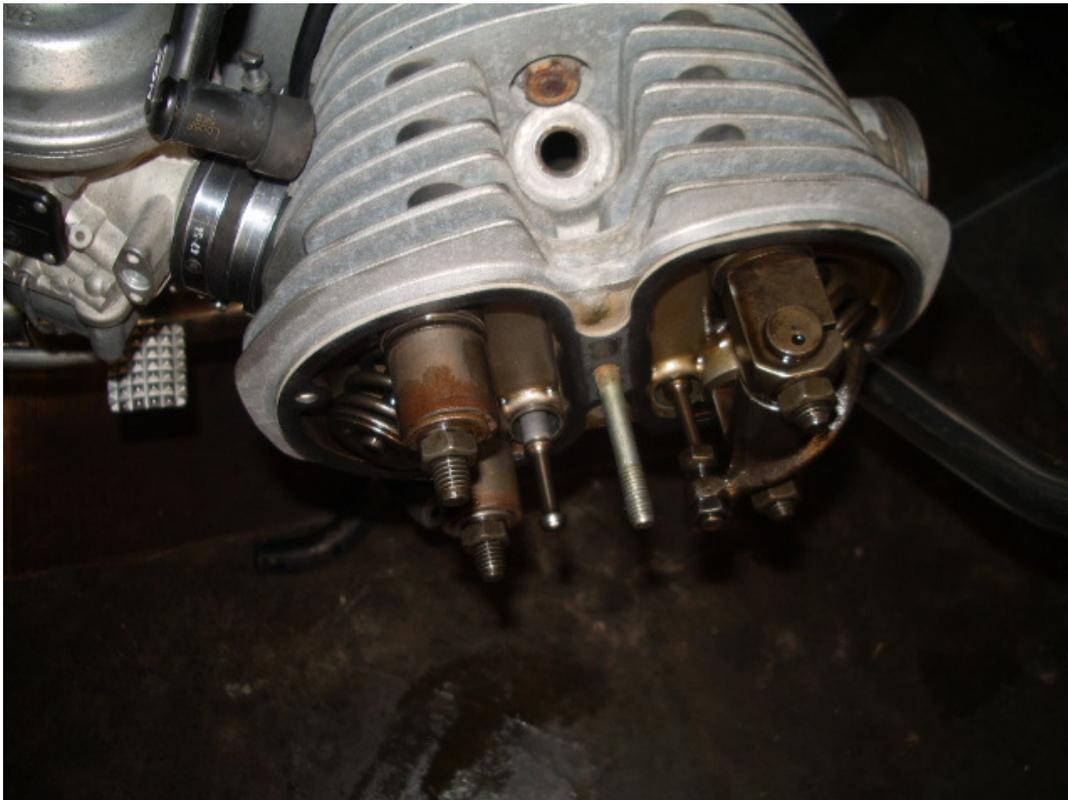
Next, Clean out the metal fragments from the head and cover, then remove the offending rocker assembly. Note the orientation of the rocker pivot rod and posts prior to removal. (oil feeds through it and their orientation is important). Then put two spacers on the head studs and apply a small amount of tension to the nuts to minimise the risk of disturbing the head and cylinder sealing. When the first side is done, then tackle the next rocker assembly. I have never experienced a gasket or sealing failure issue using this method and there should be no need to remove the head for this job.

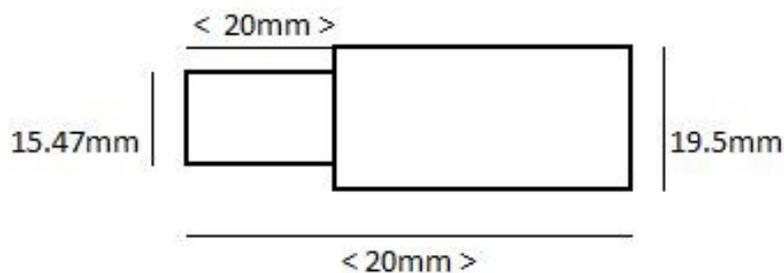
Below is a diagram showing the dimensions of the tool that I have made for the task: Access to a lathe, or your local machine shop will be required for this.

Go by feel and make your own judgement call at the time. **Nb:** *The pressing tool that I have made does not have a depth 'stop' step. If you copy this same design make sure to note the original seating position of the bearings and fit accordingly. Use your experience and common sense.*

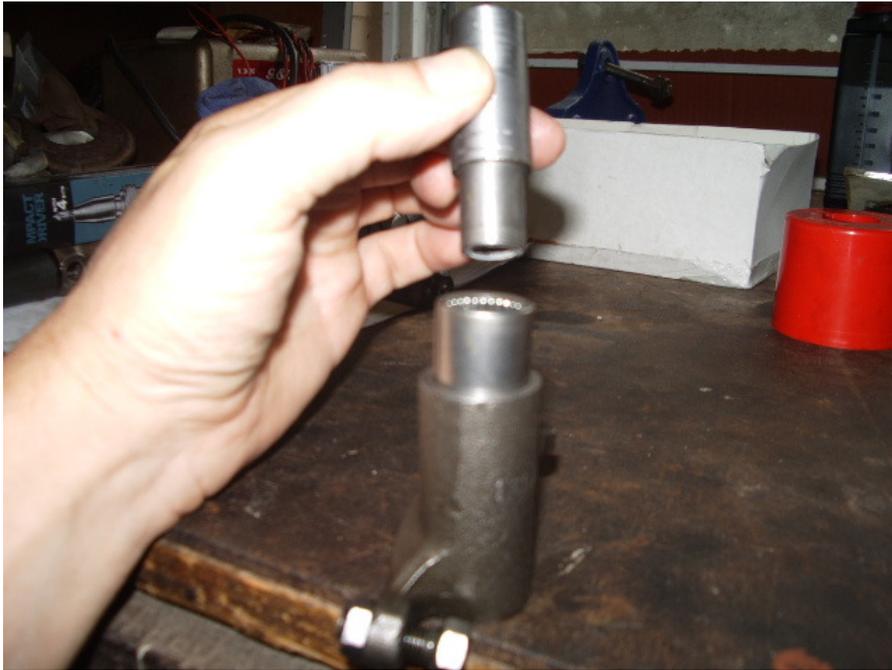
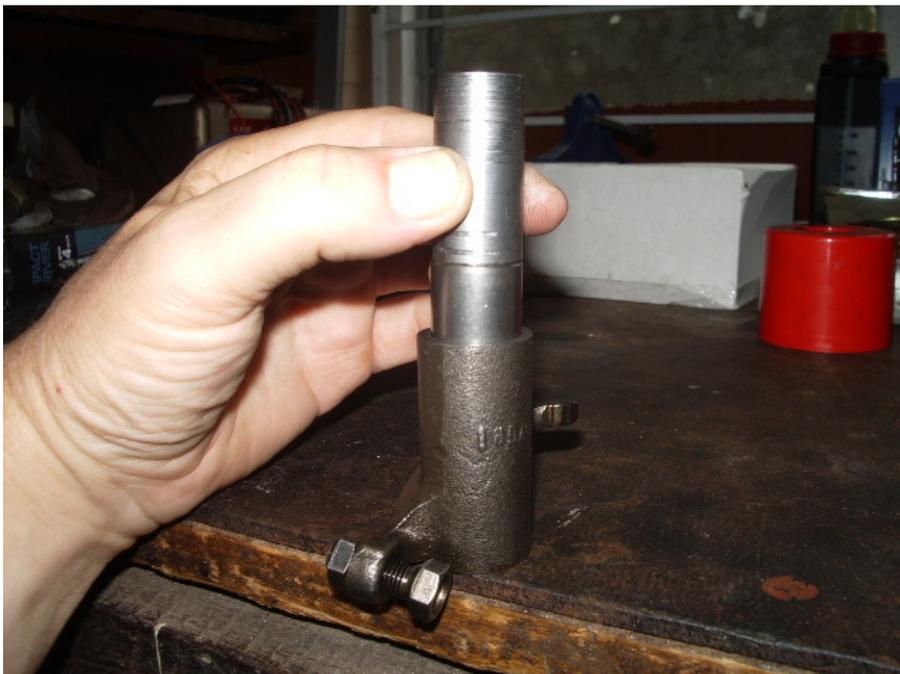
Next comes the bearing fit up. Each rocker has two needle rollers. As pictures describe the process best, you can follow the images below:

Use either a press or a vice to push the bearings into place. ***(Nb: Do not use a hammer against the pressing tool, or the bearing to tap it into place. The outer cage of needle rollers are easily damaged.)***

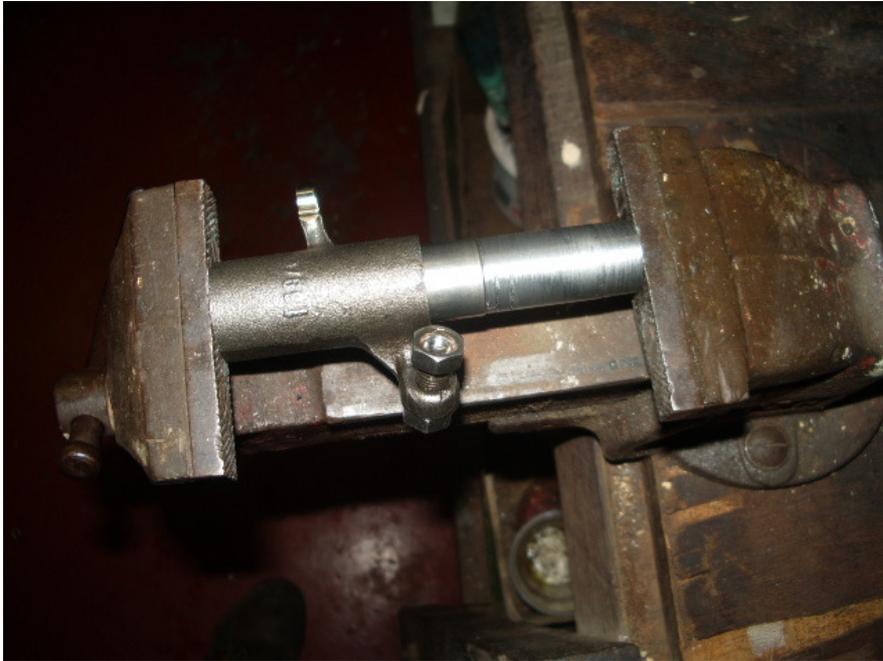
As the fit isn't overly tight, I use a small vice for this job (see below). A pair of soft jaws can be used on the rocker arm if there are any concerns about the vice jaws marking the rocker. In reality though, the bearings go in easily and I have never found them to be that tight for it to be of concern.

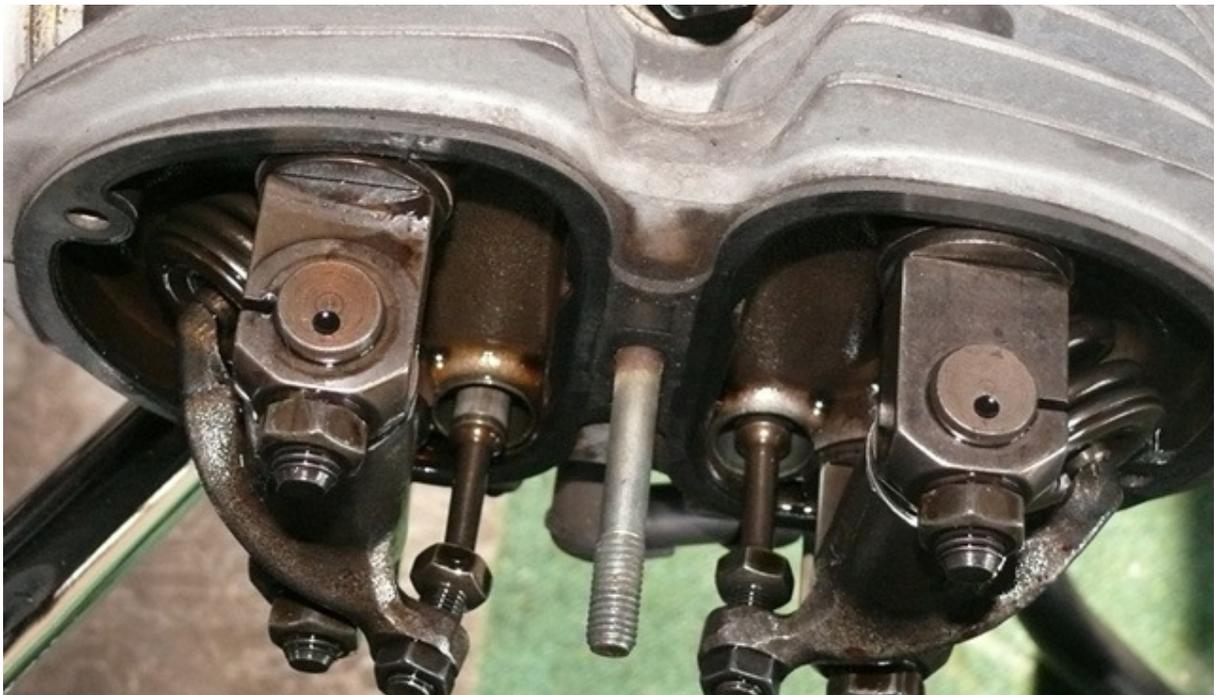
From there it's reassembly time. As that process is simply the reverse of the strip down, I won't go into that here. Remember to refit the rocker pivot rods, posts and stud nuts in their correct orientation. (Refer below)

Re-tension the head nut to the nominated specifications, set the valve clearance, replace the oil filter (*remembering to check the proverbial '\$2,000 O ring' clearance*) refill the oil, close it up and it's time to test.
